POSTLAUNCH REPORT

MERCURY-REDSTONE NO. 2

(MR-2)

Space Task Group

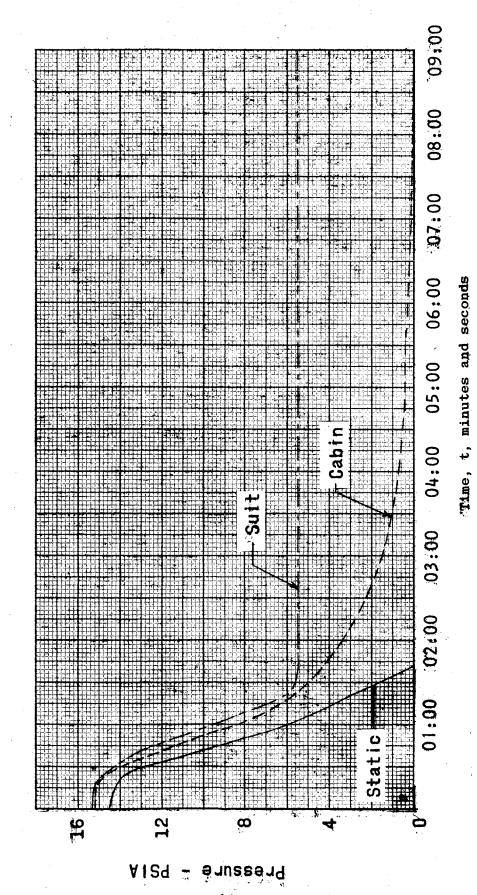
Figure 7.4-1. - Variation of suit, cabin, and static pressures with time from launch.

Although the cabin failed to maintain pressure during the flight, the emergency suit system operated as designed and provided a satisfactory environment for the animal occupant, Figure 7.4-1. The following sequence of events has been established as a result of analyses of the available data:

- (a) During ascent, at 00:57, the inflow snorkel valve opened, placing the suit circuit in the postlanding mode, and causing the cabin pressure to decay to a value slightly above ambient through the negative pressure relief valve and then through the open inlet snorkel. This condition occurred at approximately 18,000 feet.

- (b) The suit circuit maintained approximately design conditions for the duration of the flight.
- (c) The cabin pressure increased during descent, at first through the cabin relief valve and then through the outflow snorkel valve when this opened at 20,000 feet. It is believed that the inlet snorkel valve was operated either by vibration or by premature squib firing. At actuation of this valve, three events properly occurred:

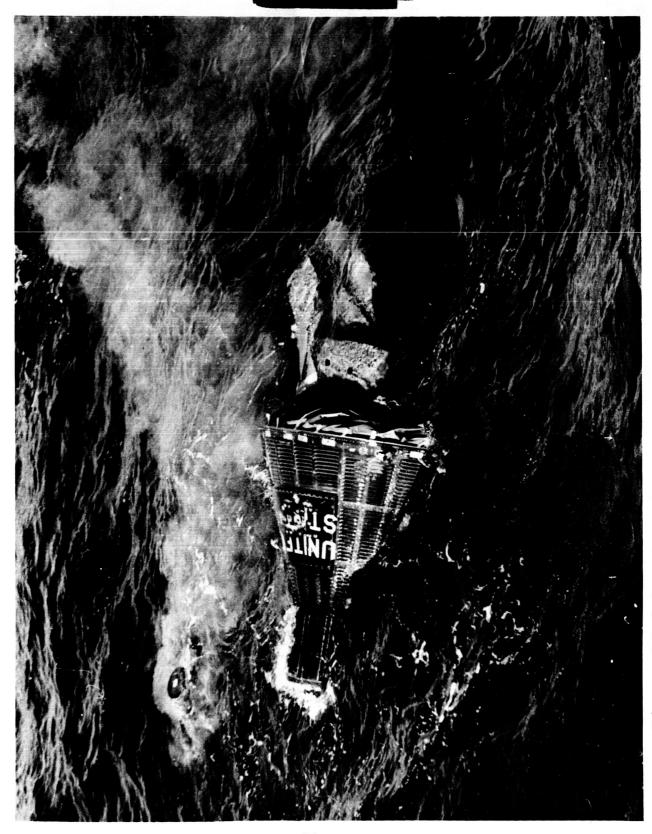
Figure 10.2-2.- Capsule shortly before pick-up.

The helicopters and also the destroyer arriving on scene observed the list angle to have increased to about 90° shortly before pickup was made. The open end of the cylindrical part of the capsule was mostly submerged with the top of the unsubmerged portion an estimated 5 to 8 inches out of the water. Upon arrival on the capsule scene the destroyer measured the following conditions:

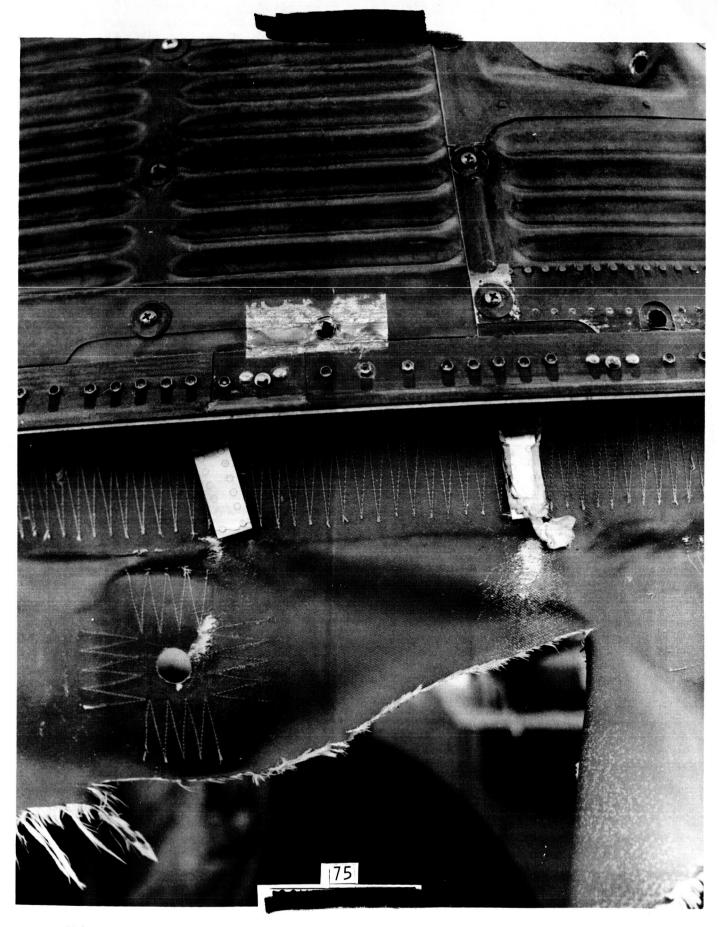
Figure 11.0-1. - Photograph showing broken retention straps and torn impact landing skirt.

- l. The heat sink was missing, as was most of the fiber-glass impact skirt, which was torn all the way around. All of the stainless steel straps were broken at approximately the same section, i.e., near the lower spot-weld at the upper attachment. This can be seen in Figure 11.0-1. The fiber-glass shield beneath the large pressure bulkhead was pierced by five deep cuts (Fig. 11.0-2), which corresponded in spacing to the positions of the heat shield studs.
- 2. The large pressure bulkhead was punctured (Fig. 11.0-3) by two of the bolts on the terminal block immediately above the damaged area on the fiberglass shield. The larger of these holes was approximately 0.16 inch in diameter.

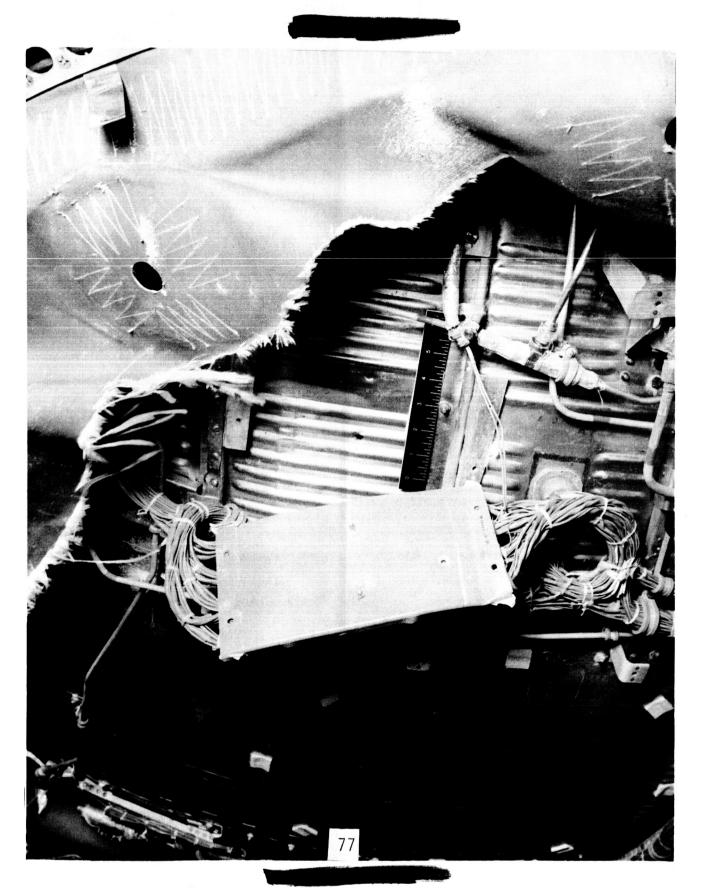
Figure 11.0-3.- View of punctures in large pressure bulkhead.

The landing bag struck the bottom of the capsule at impact puncturing two small holes in the lower pressure bulk-head (see Section 11.0). It is believed that at some time after impact, wave action fatigued the straps, breaking them from the capsule and allowing the heat shield to sink. The reduced water stability of the capsule without the heat sink caused it to eventually lay over on its side in a near horizontal position. Water may then have entered the capsule through the outlet snorkel and cabin pressure relief valves. The capsule took on a considerable amount of water. In fact, as reported later in Section 10, it was near submersion at the time of recovery.

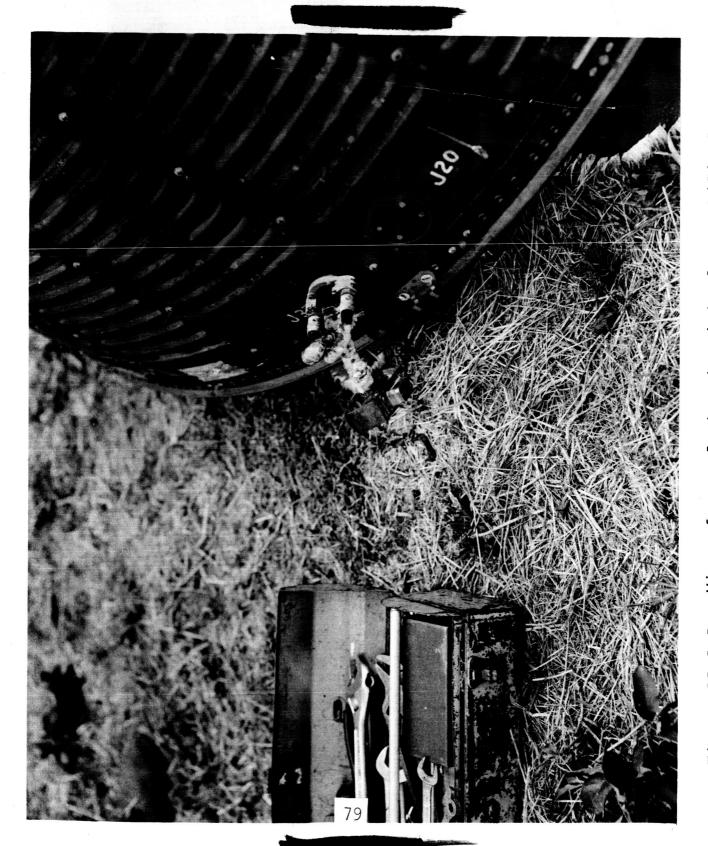
Figure 11.1-1.- View of capsule-booster interface umbilical.

All pyrotechnics fired with no apparent misfires. However, the capsule lower umbilical disconnect did not separate (see Section 11.1). As discussed in Section 7.4, premature squib firing could have caused the inlet snorkel valve to open prematurely.

- 1. The J37 umbilical disconnect was still attached to the capsule. Both explosive cells had fired, but a shear pin still held, and the lock ring was still in place. The plug was wedged in its socket at an angle. The exposed wiring and socket were badly burned, as can be seen in Figure 11.1-1.

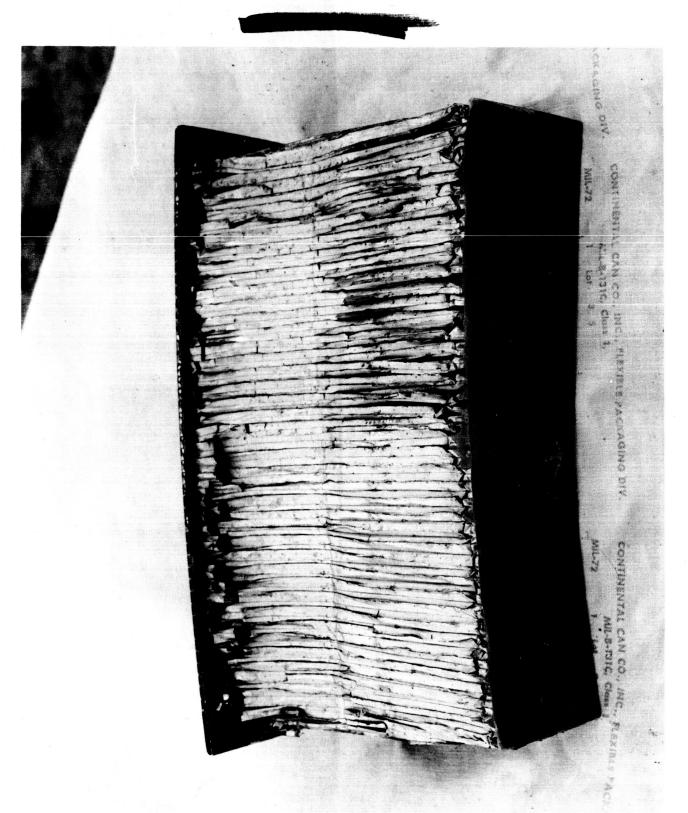
Figure 11.1-2.- View of damaged crushable couch support block.

- 5. The crushable couch support blocks were damaged, (Fig. 11.1-2). This was apparently caused by the blocks rolling over onto the bulkhead stiffener either on installation or removal of the couch. These blocks are not attached to the capsule structure and it is believed that this damage did not result from the flight test.
